RIVER RANCH/DOVER ISLAND RESTORATION

YELLOWSTONE RIVER BILLINGS, MONTANA

FEASIBILITY ANALYSIS

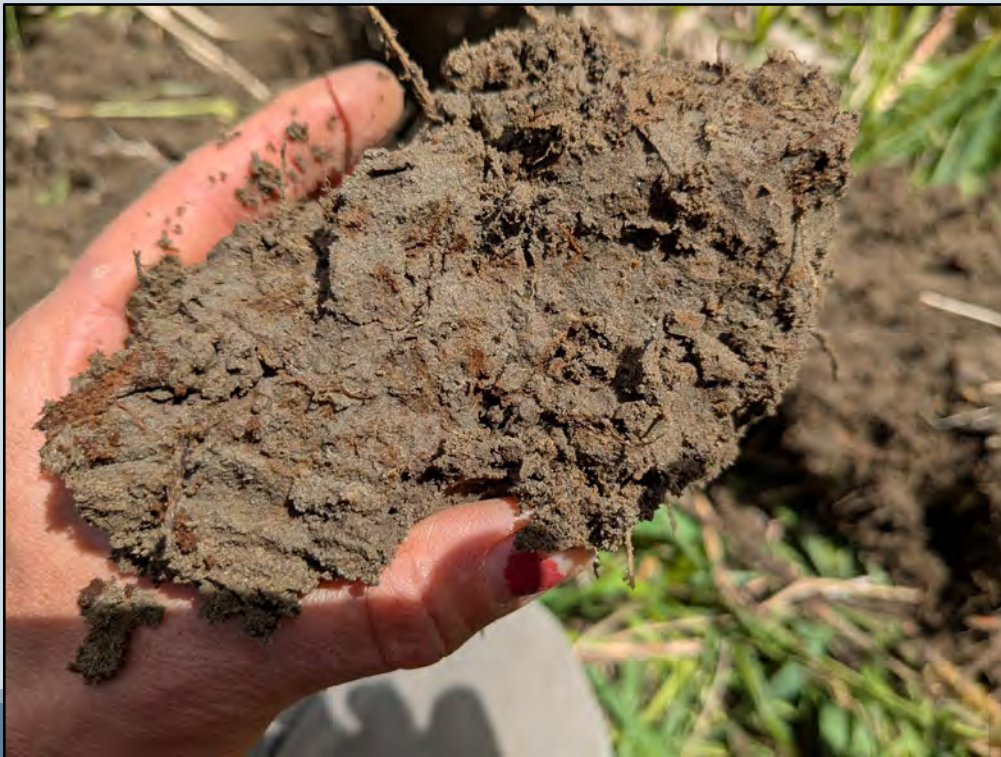
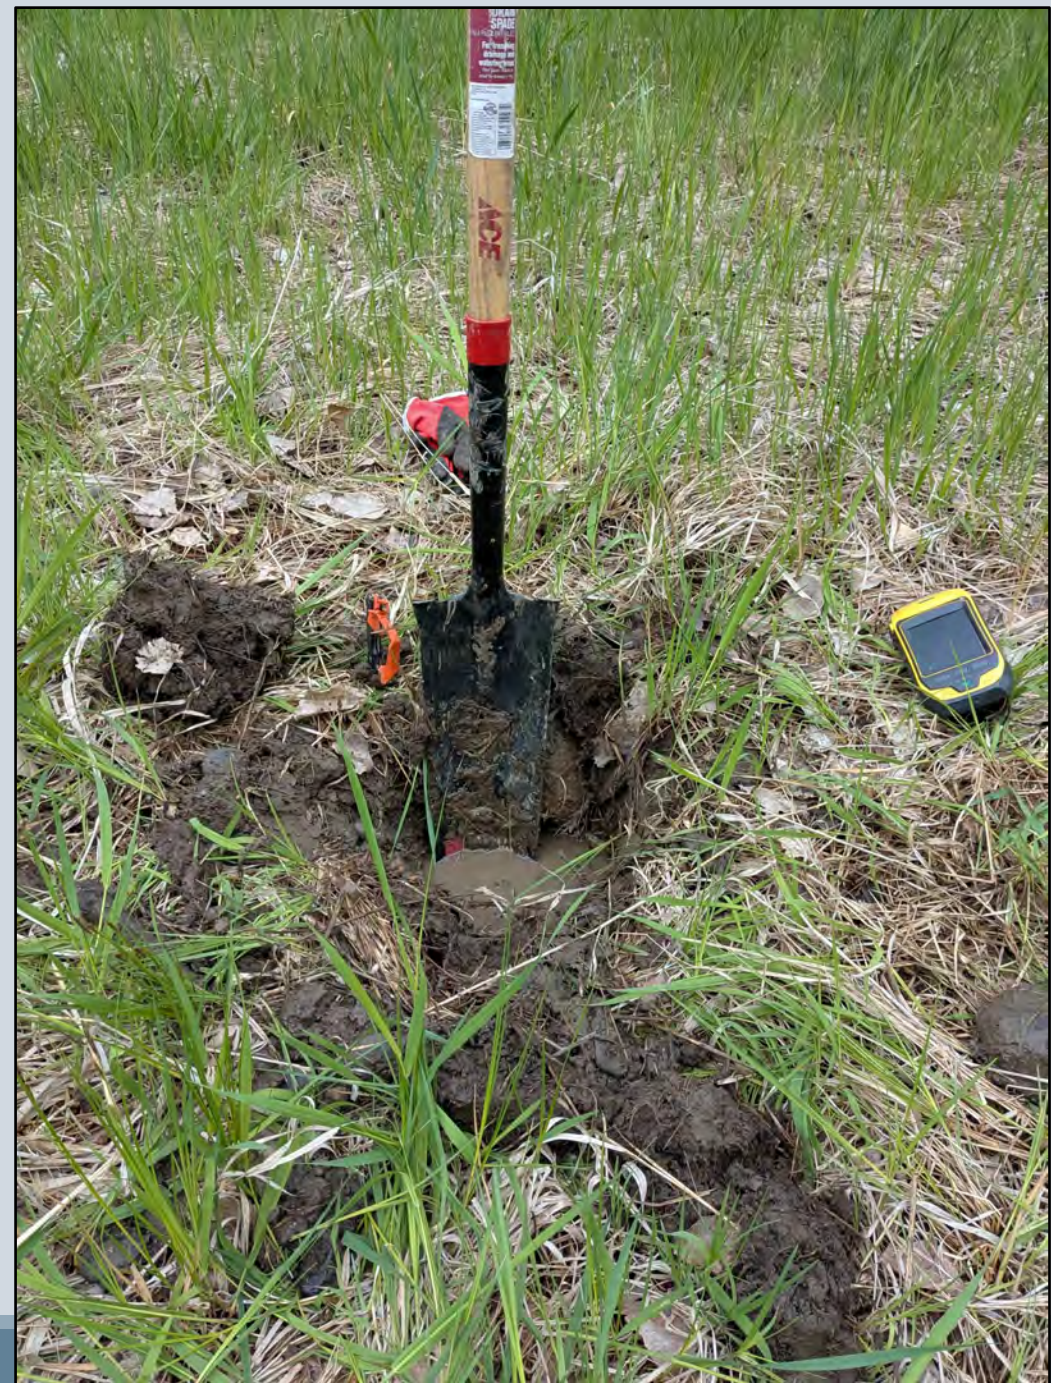
WETLAND DELINEATION

- Additional evidence of loss of connectivity
- Soil redox features found on high surfaces

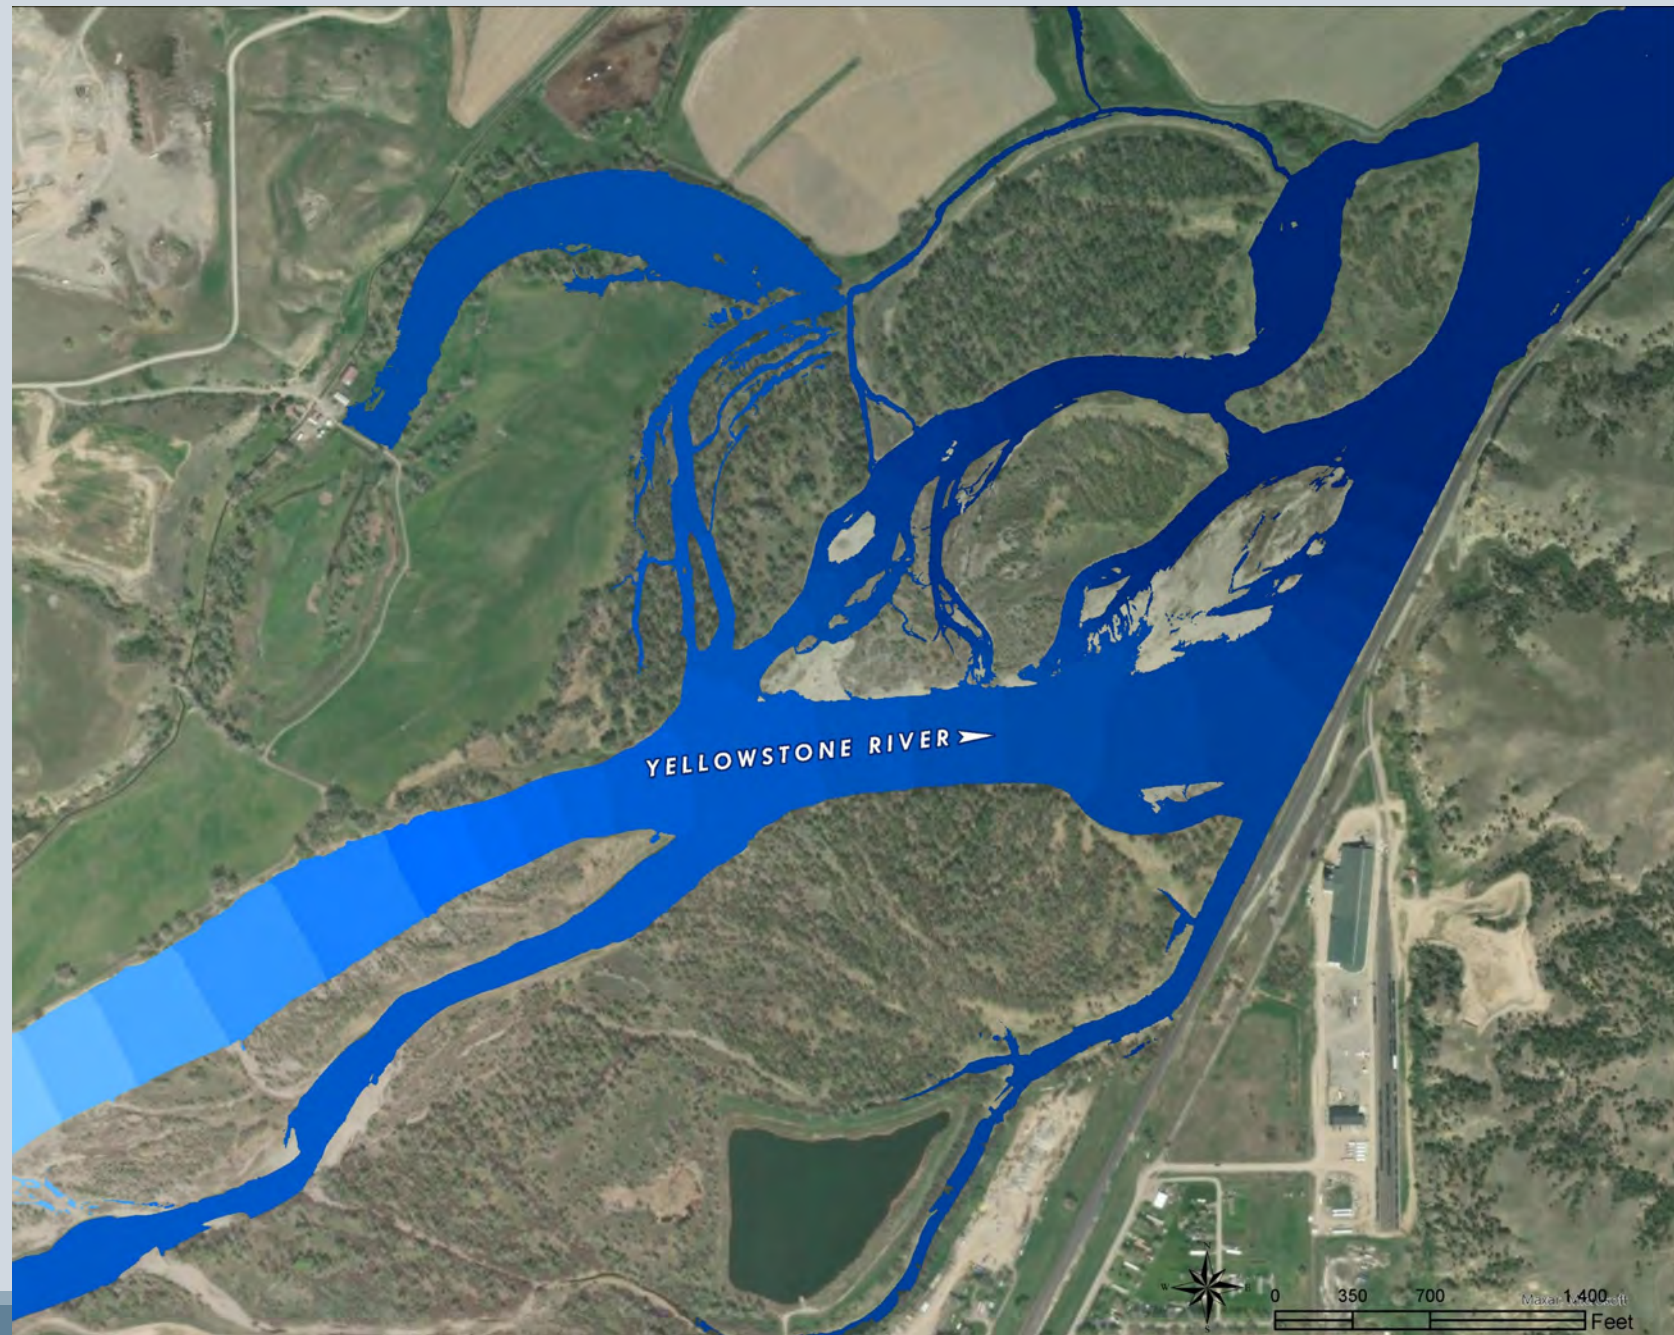
DESIGN UPDATES

1950's side channel activation at
1.5 year return flow
